## Locomotive horn evaluation: effectiveness at operating speeds

This study examined locomotive horn placement and sound emission levels, and made recommendations to ensure that horns provide adequate warning while addressing noise concerns from crews and residents near the tracks. The report includes detailed technical specifications for horns and their placement on the locomotive that would make them a more effective warning device.

*Locomotive horn evaluation: effectiveness at operating speeds,*  
Transys Research Ltd., 2003  
TP 14103E

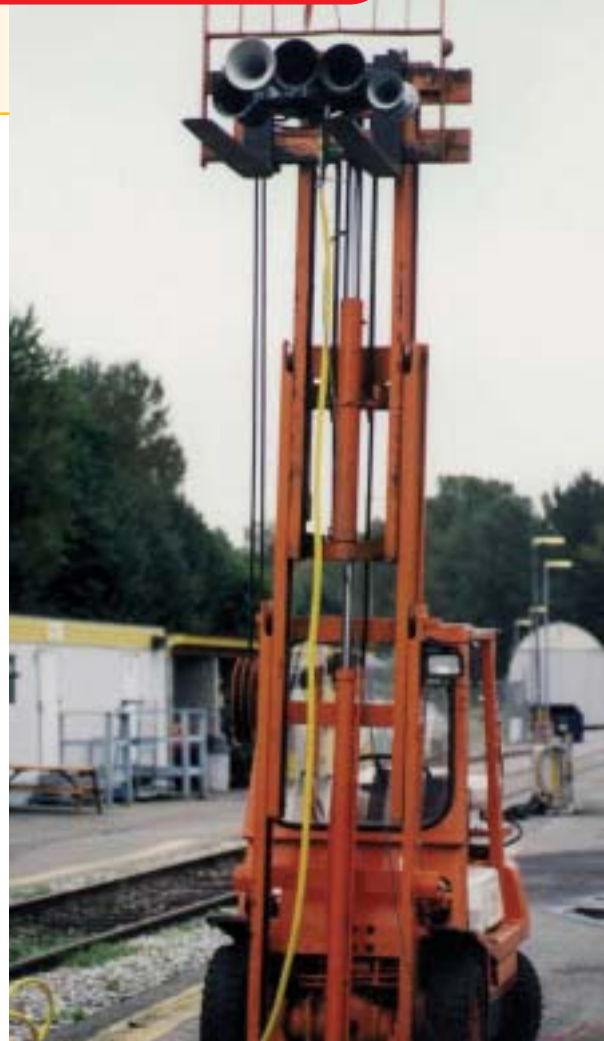
*Test rig used to measure sound output.*

The study found that the location of the horn was very important to its effectiveness. Sound output in front of the train deteriorates as speed increases, unless the horn is located at the front of the engine. Horns mounted behind or close to the engine exhaust hood performed worse than in any other location.
